Bridge Building, Barnstaple

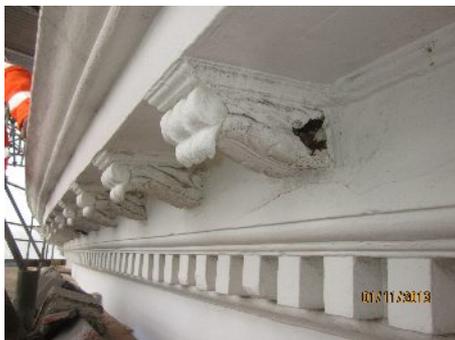
Entablature prior to strip

A new phase of work was undertaken during 2013 to carry out repairs to the timber brackets on the underside of the projecting cornice of this prominent listed building. The opening up has revealed that the hand carved timber brackets which support the underside of the cornice (in visual terms only) were considerably more rotten than appeared from the outside, where they were encased in many coats of heavy paint which maintained the outside form while the timber inside rotted away. These are now being re-carved by hand in hardwood, with the sections touching the masonry protected with epoxy resin as a damp proof coat, before being repainted.

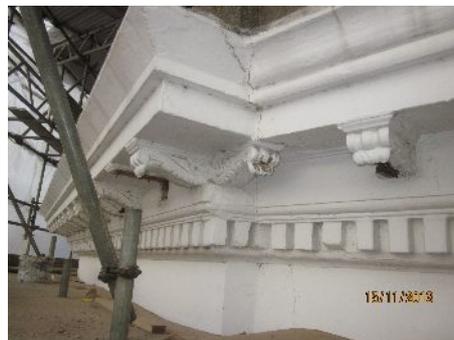
Prior to strip

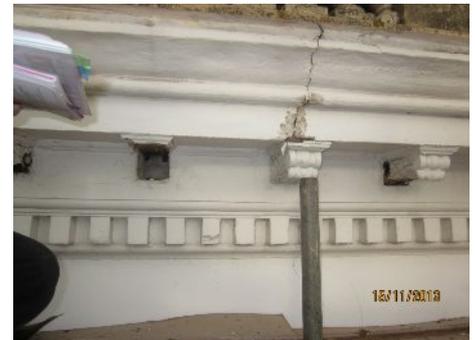
Bracket removed

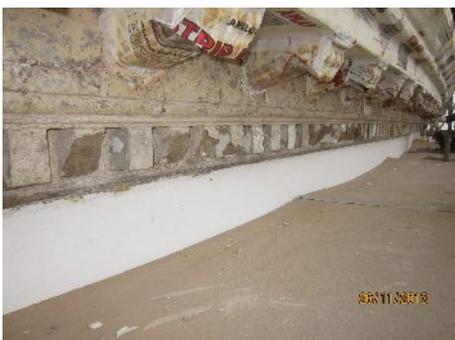
Stripping under way

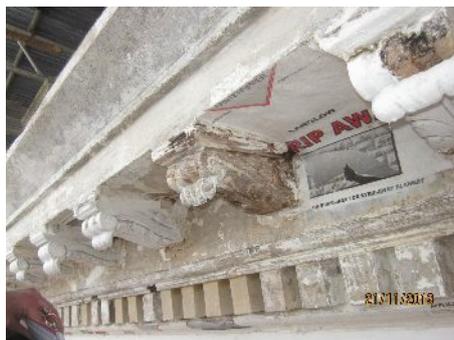
Stripping and dentil repairs

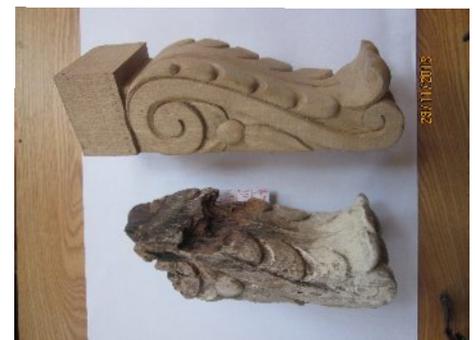
New and existing brackets
